DEPARTMENT OF TRANSPORTATION

Contract #: 04-0120F4Cty: SF/ALA Rte: 80 PM: 13.2/13.9File #: 69.28**WELDING INSPECTION REPORT****Resident Engineer:**Siegenthaler, Peter**Address:** 333 Burma Road**City:** Oakland, CA 94607**Report No:** WIR-018120**Date Inspected:** 14-Nov-2010**Project Name:** SAS Superstructure**OSM Arrival Time:** 700**Prime Contractor:** American Bridge/Fluor Enterprises, a JV**OSM Departure Time:** 1900**Contractor:** Zhenhua Port Machinery Company, Ltd (ZPMC), Changxing Island **Location:** Shanghai, China**CWI Name:** Zhu Zhong Hai**CWI Present:** Yes No**Inspected CWI report:** Yes No N/A**Rod Oven in Use:** Yes No N/A**Electrode to specification:** Yes No N/A**Weld Procedures Followed:** Yes No N/A**Qualified Welders:** Yes No N/A**Verified Joint Fit-up:** Yes No N/A**Approved Drawings:** Yes No N/A**Approved WPS:** Yes No N/A**Delayed / Cancelled:** Yes No N/A**Bridge No:** 34-0006**Component:** Orthotropic Box Girder(OBG)**Summary of Items Observed:**

OBG TRIAL ASSEMBLY YARD

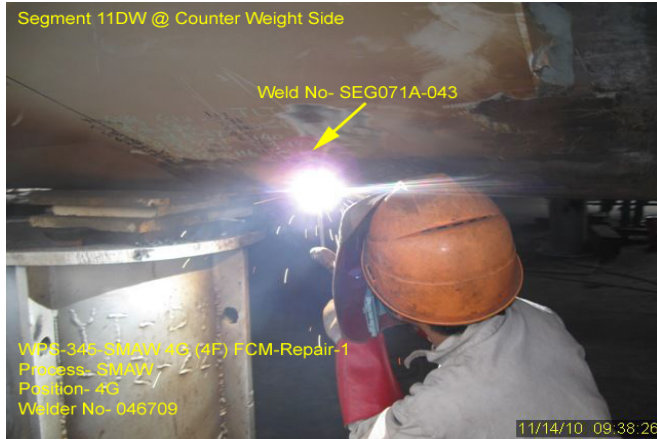
WELDING:**Segment 11DW**

This QA Inspector observed ZPMC qualified welding personnel identified as 046709 perform Shielded Metal Arc Welding (SMAW), weld joint identified as SEG071A-043; located On Orthotropic Box Girder (OBG) Bottom Plate to Side Plate CJP Weld. The Welding Repair Report (WRR) was B-WR16939. ZPMC QC is identified as Mr.Zhu Zhong Hai. The welding parameters measured using QC's calibrated instrument appeared to be in general compliance with applicable WPS-345-SMAW 4G (4F) FCM-Repair-1. See attached photo for further details.

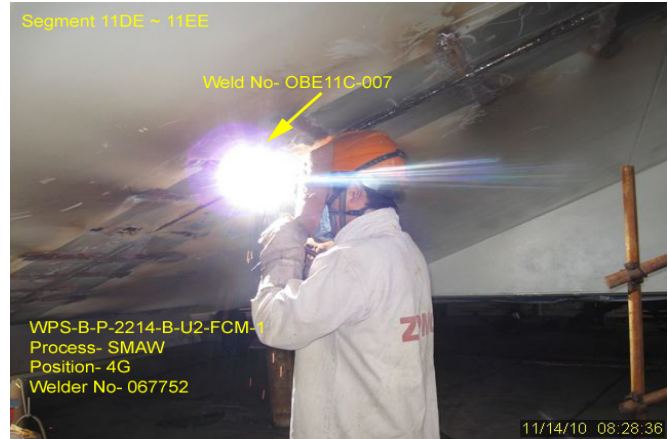
Segment 11CE ~ 11DE

This QA Inspector observed ZPMC qualified welding personnel identified as 067752 perform Shielded Metal Arc Welding (SMAW), weld joint identified as OBE11C-007; located On Orthotropic Box Girder (OBG) Side Plate to Side Plate Transverse CJP Weld; ZPMC Quality Control (QC) is identified as Mr. Wang Li Yang. The welding variables recorded by QC appeared to comply with applicable WPS-B-P-2214-B-U2-FCM-1. See attached photo for further details.
